## Management Survey For

**The Chocolate Box, The Street, Acle, Norwich, Norfolk, NR13 3DY**

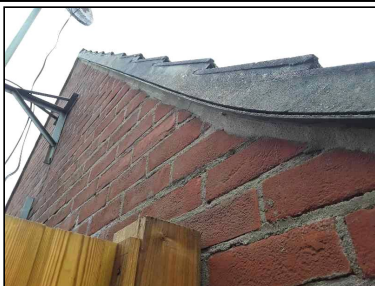
| | 1 Oct 2020 | | Shaun Applegate | Management Survey | External | Chrysotile (1) |
| | 1 | SA002203 (S) | Asbestos Cement (1) | Surface Sealed (1) | Low Damage (1) | Usually inaccessible or unlikely to be disturbed |
| Surveyor comments | | See external drawing for orientation. | | | | |

| Recommended action | | No Attention Required - Manage by ensuring anyone likely to disturb are made aware of the presence of asbestos, label (where practical) and inspect at intervals (see Recommendations) | | | | |

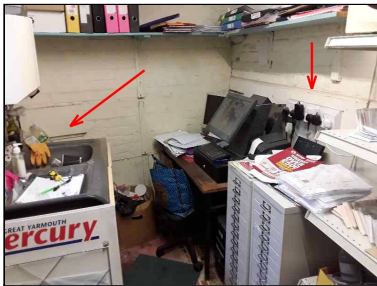
| | Survey Date: | | Lead Surveyor | Survey Type | Floor | Analysis |
|---|---|---|---|---|---|---|
| | 1 Oct 2020 | | Shaun Applegate | Management Survey | Ground Floor | Chrysotile (1) |
| | 8 | SA002207 (S) | Asbestos Cement (1) | Surface Sealed (1) | Low Damage (1) | Occasionally likely to be disturbed |

| | Survey Date: | | Lead Surveyor | Survey Type | Floor | Analysis |
|---|---|---|---|---|---|---|
| Recommended action | No Attention Required - Manage by ensuring anyone likely to disturb are made aware of the presence of asbestos, label (where practical) and inspect at intervals (see Recommendations) | | | | | |

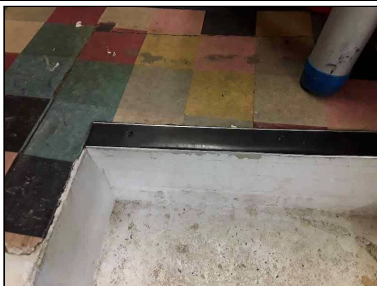
| | 1 Oct 2020 | | Shaun Applegate | Management Survey | Ground Floor | Chrysotile (1) |
| | 10 | Visual (P) | Reinforced Composite (1) | Completely Sealed (0) | Good Condition (0) | Easily disturbed |
| Surveyor comments | | Presumed to contain asbestos as obtaining sample would cause excessive damage. | | | | |

| Recommended action | | No Attention Required - Manage by ensuring anyone likely to disturb are made aware of the presence of asbestos, label (where practical) and inspect at intervals (see Recommendations) | | | | |

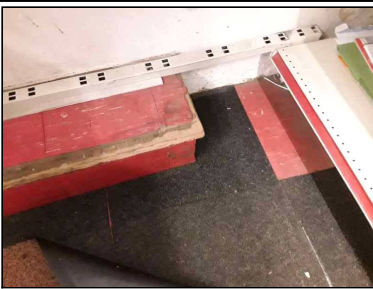
| | 1 Oct 2020 | | Shaun Applegate | Management Survey | Ground Floor | Chrysotile (1) |
| | 11 | SA002209 (S) | Well Bound Material (1) | Completely Sealed (0) | Low Damage (1) | Occasionally likely to be disturbed |
| Surveyor comments | | Presumed to be situated beneath the top layer of bright red tiles. Limited inspection access. A sample of the floor tiles & the bitumen backing/adhesive was sent for laboratory analysis. Upon receipt of the analysis results it was established that Chrysotile (white asbestos) was present to both the floor tiles & the bitumen backing/adhesive. | | | | |

| Recommended action | | No Attention Required - Manage by ensuring anyone likely to disturb are made aware of the presence of asbestos, label (where practical) and inspect at intervals (see Recommendations) | | | | |

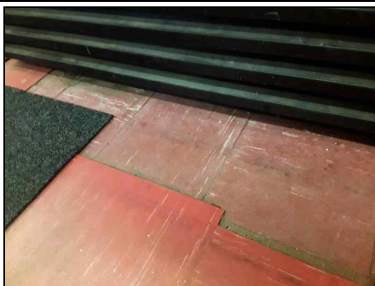
| | 1 Oct 2020 | | Shaun Applegate | Management Survey | Ground Floor | Chrysotile (1) |
| | 13 | As SA002209 (SP) | Well Bound Material (1) | Completely Sealed (0) | Low Damage (1) | Occasionally likely to be disturbed |
| Surveyor comments | | Situated beneath the top layer of bright red tiles. Limited inspection access. A sample of the floor tiles & the bitumen backing/adhesive was sent for laboratory analysis. Upon receipt of the analysis results it was established that Chrysotile (white asbestos) was present to both the floor tiles & the bitumen backing/adhesive. | | | | |

| Recommended action | | No Attention Required - Manage by ensuring anyone likely to disturb are made aware of the presence of asbestos, label (where practical) and inspect at intervals (see Recommendations) | | | | |
