## Management Survey For

**The Chocolate Box, The Street, Acle, Norwich, Norfolk, NR13 3DY**

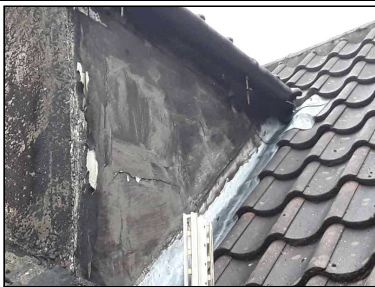
| Surveyor comments | | See external drawing for orientation. | | | | |

| Recommended action | | No Attention Required - Manage by ensuring anyone likely to disturb are made aware of the presence of asbestos, label (where practical) and inspect at intervals (see Recommendations) | | | | |

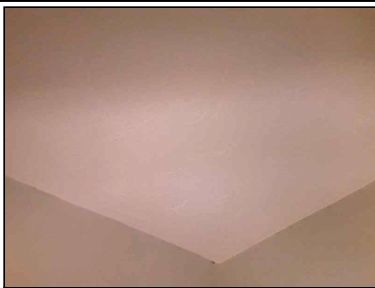
| Surveyor comments | The textured coatings within locations: G1, G2, G3 & G6 were deemed to be of the same composition. Subsequent representative sample / scrapings from all areas were included in the sample bag submitted for analysis to ensure a definitive & accurate result. | | | | | |

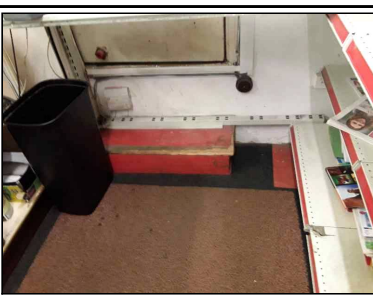
| Surveyor comments | | Presumed to be situated beneath the top layer of bright red tiles. Limited inspection access. A sample of the floor tiles & the bitumen backing/adhesive was sent for laboratory analysis. Upon receipt of the analysis results it was established that Chrysotile (white asbestos) was present to both the floor tiles & the bitumen backing/adhesive. | | | | |

| Recommended action | | No Attention Required - Manage by ensuring anyone likely to disturb are made aware of the presence of asbestos, label (where practical) and inspect at intervals (see Recommendations) | | | | |

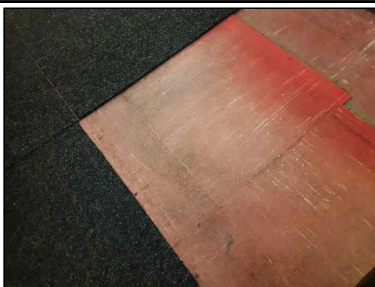
| Surveyor comments | | Situated beneath the top layer of bright red tiles. Limited inspection access. A sample of the floor tiles & the bitumen backing/adhesive was sent for laboratory analysis. Upon receipt of the analysis results it was established that Chrysotile (white asbestos) was present to both the floor tiles & the bitumen backing/adhesive. | | | | |

| Recommended action | | No Attention Required - Manage by ensuring anyone likely to disturb are made aware of the presence of asbestos, label (where practical) and inspect at intervals (see Recommendations) | | | | |
